## CENTRAL POWER RESEARCH INSTITUTE

: Routine & type tests on 3Ø, 25 kvar, 440 V, 50 Hz, LV shunt capacitor-.

# TEST REPORT

: PCD -0057

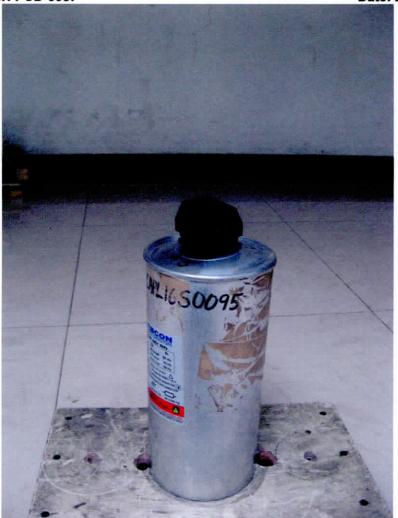
Photograph- 1: A view of the test capacitor on completion of destruction test

Measured capacitor current at 572Vac: 0.3A, which was lower than 66% of the initial current at  $1.3~\text{U}_\text{N}$  ac. Therefore the test procedure was interrupted and the capacitor was cooled to ambient temperature.

Test Result: 1) Sample withstood the test

2) No escaping liquid material observed on the surface of the capacitor

3) Capacitor container has not broken 4) No flame or fiery particles observed

A view of the test sample after destruction test is as shown in photograph no.1.
